# Manhole Inspection Summary

Manhole # S29I\_\_005MH

Insp Date: **9/10/08 12:12 PM**

**Location** Address: **701 W. Pratt**

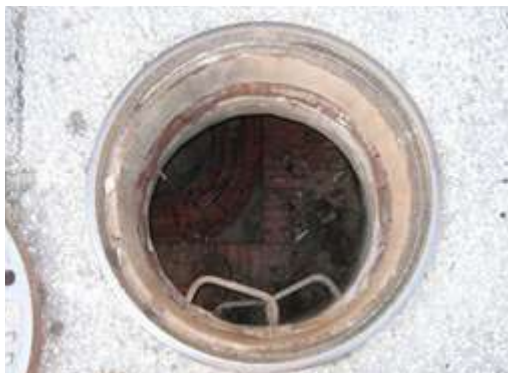
Frame View

**Frame** Offset: **0** (in.) Condition: ☒ Sound ☐ Cracked ☐ Leaks

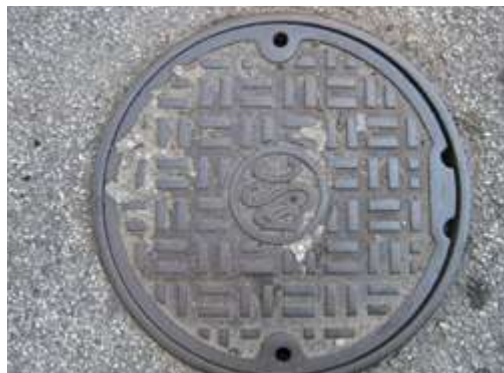
Cover View

Type: **Sanitary** Condition: **Sound** Cover Material: **Cast Iron**

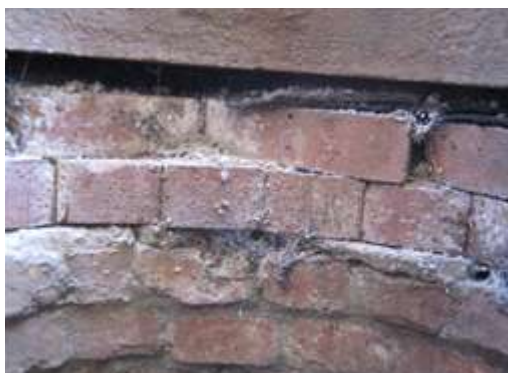
Defect 2

Condition: ☐ Sound ☒ **Cracked** ☐ Root Intrusion ☒ **Loose Brick** ☐ Deteriorated

Loose bricks and mortar in chimney

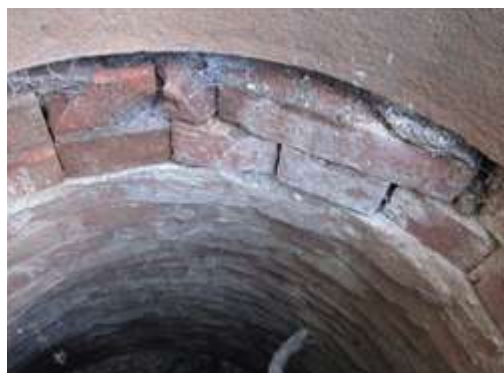
defect 1

additional view-Loose bricks and mortar in chimney

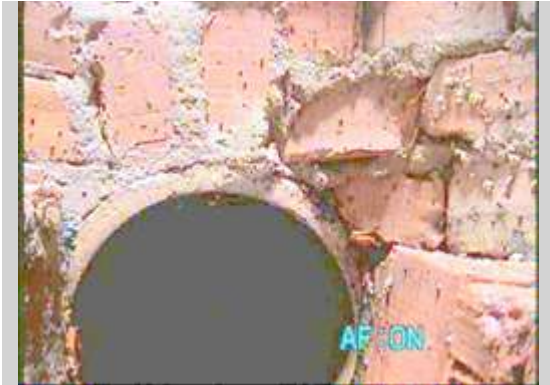
12 O'Clock Outflow

10 in. Circular Gravity Sewer  
Pipe Out @ 12 O'Clock

Pipe Height: **10.8** (in.) Rod and Bar (Angled)  
Pipe Material: **Clay** ☐ Pipe Lined  
Invert Depth: **7.19** (ft.) Flow Characteristics: **Slow**  
Deposits: ☒ None ☐ Mud ☐ Sludge ☐ Debris ☐ Grease  
Silt Depth: **0** (in.) Deposits Extent:  
Infiltration: **None** Pipe Seal Cond: **Sound**

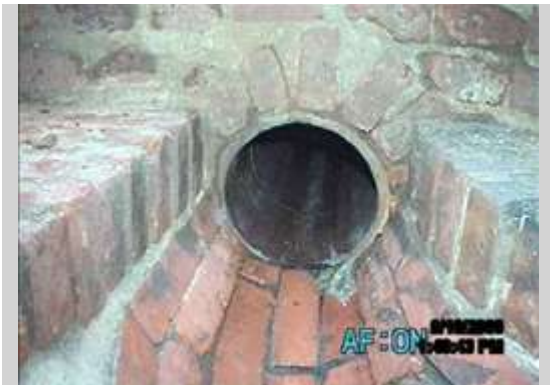
8 O'Clock Inflow

8 in. Circular Gravity Sewer  
Pipe In @ 9 O'Clock

Pipe Height: **8.4** (in.) Rod and Bar (Angled)  
Pipe Material: **Clay** ☐ Pipe Lined  
Invert Depth: **7.00** (ft.) Flow Characteristics: **Slow**  
Deposits: ☒ None ☐ Mud ☐ Sludge ☐ Debris ☐ Grease  
Silt Depth: **0** (in.) Deposits Extent:  
Infiltration: **None** Pipe Seal Cond: **Sound**
